# MGB Brake Master Cylinder Rebuilding

*(Reprinted from the Sports Car Chronicle – Summer, 2008)*

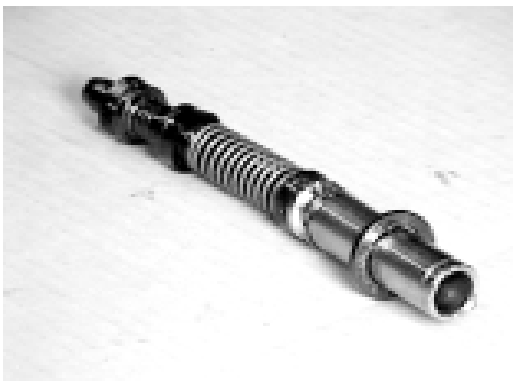
"The Guts" Primary & secondary piston assembly

The primary & secondary piston assembly can now be pulled out of the cylinder.

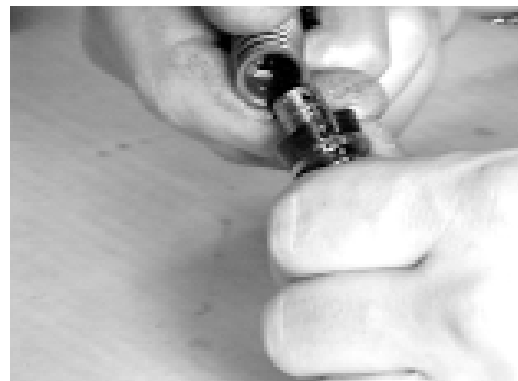
Separating the primary & secondary pistons for seal replacement.

An extra pair of hands will prove to be indispensable!

There is a metal link securing the secondary piston to the end of the primary piston. This link needs to be removed in order to replace the rubber seals on both pistons. A coil spring is wrapped around the outside of the link.

Pull back the coil spring and its metal sleeve from the end of the primary piston. Using a small pin punch and hammer, drive out the roll pin. This will allow you to separate the primary & secondary piston assemblies.

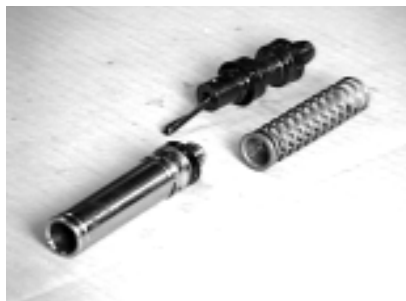
Everything separated – ready for seal replacement.

Please take careful note of the direction of the lip type seals. Installing one backwards will result in a non-functional master cylinder!

Remove the rubber seals and thin piston washers from the primary & secondary pistons. Check the condition of the pistons. The outside surfaces should be smooth and free from any damage. If the pistons are not in excellent condition, the cylinder assembly should be scrapped!

Coat them with brake lube or clean fluid. Install the new seals, with washers where appropriate, using only the fingers!

Using pliers or screwdrivers may tear or damage the seal surfaces. Ensure that the seal lips are correctly oriented.
