# MGB Brake Master Cylinder Rebuilding

*(Reprinted from the Sports Car Chronicle – Summer, 2008)*

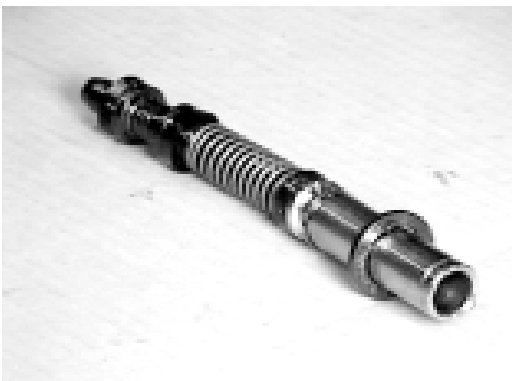
"The Guts" Primary & secondary piston assembly

The primary & secondary piston assembly can now be pulled out of the cylinder.
