# MGB Kingpins & Front Suspension

*(Reprinted from the Sports Car Chronicle – Fall, 2008)*

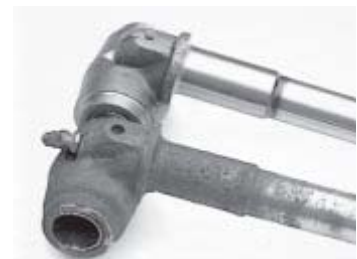
The fulcrum bush in the bottom of the kingpin shown here is almost worn right through on the lower left hand side. The bush has become oval shaped, instead of round, as it should be.

It just goes to show you how important it is to grease that bottom 'Zerk' fitting on the kingpin once in a while!

Look how badly the bearing surface for the lower stub axle bush is worn on the bottom kingpin. Compare it against the same area on the new kingpin above it.

This will cause significant tire wear and poor driveability!
